**BLACKSTONE RIVER BASIN
MILLBURY, MASSACHUSETTS**

**RAMSHORN POND DAM
MA 00145**

PHASE I INSPECTION REPORT NATIONAL DAM INSPECTION PROGRAM

JULY 1978

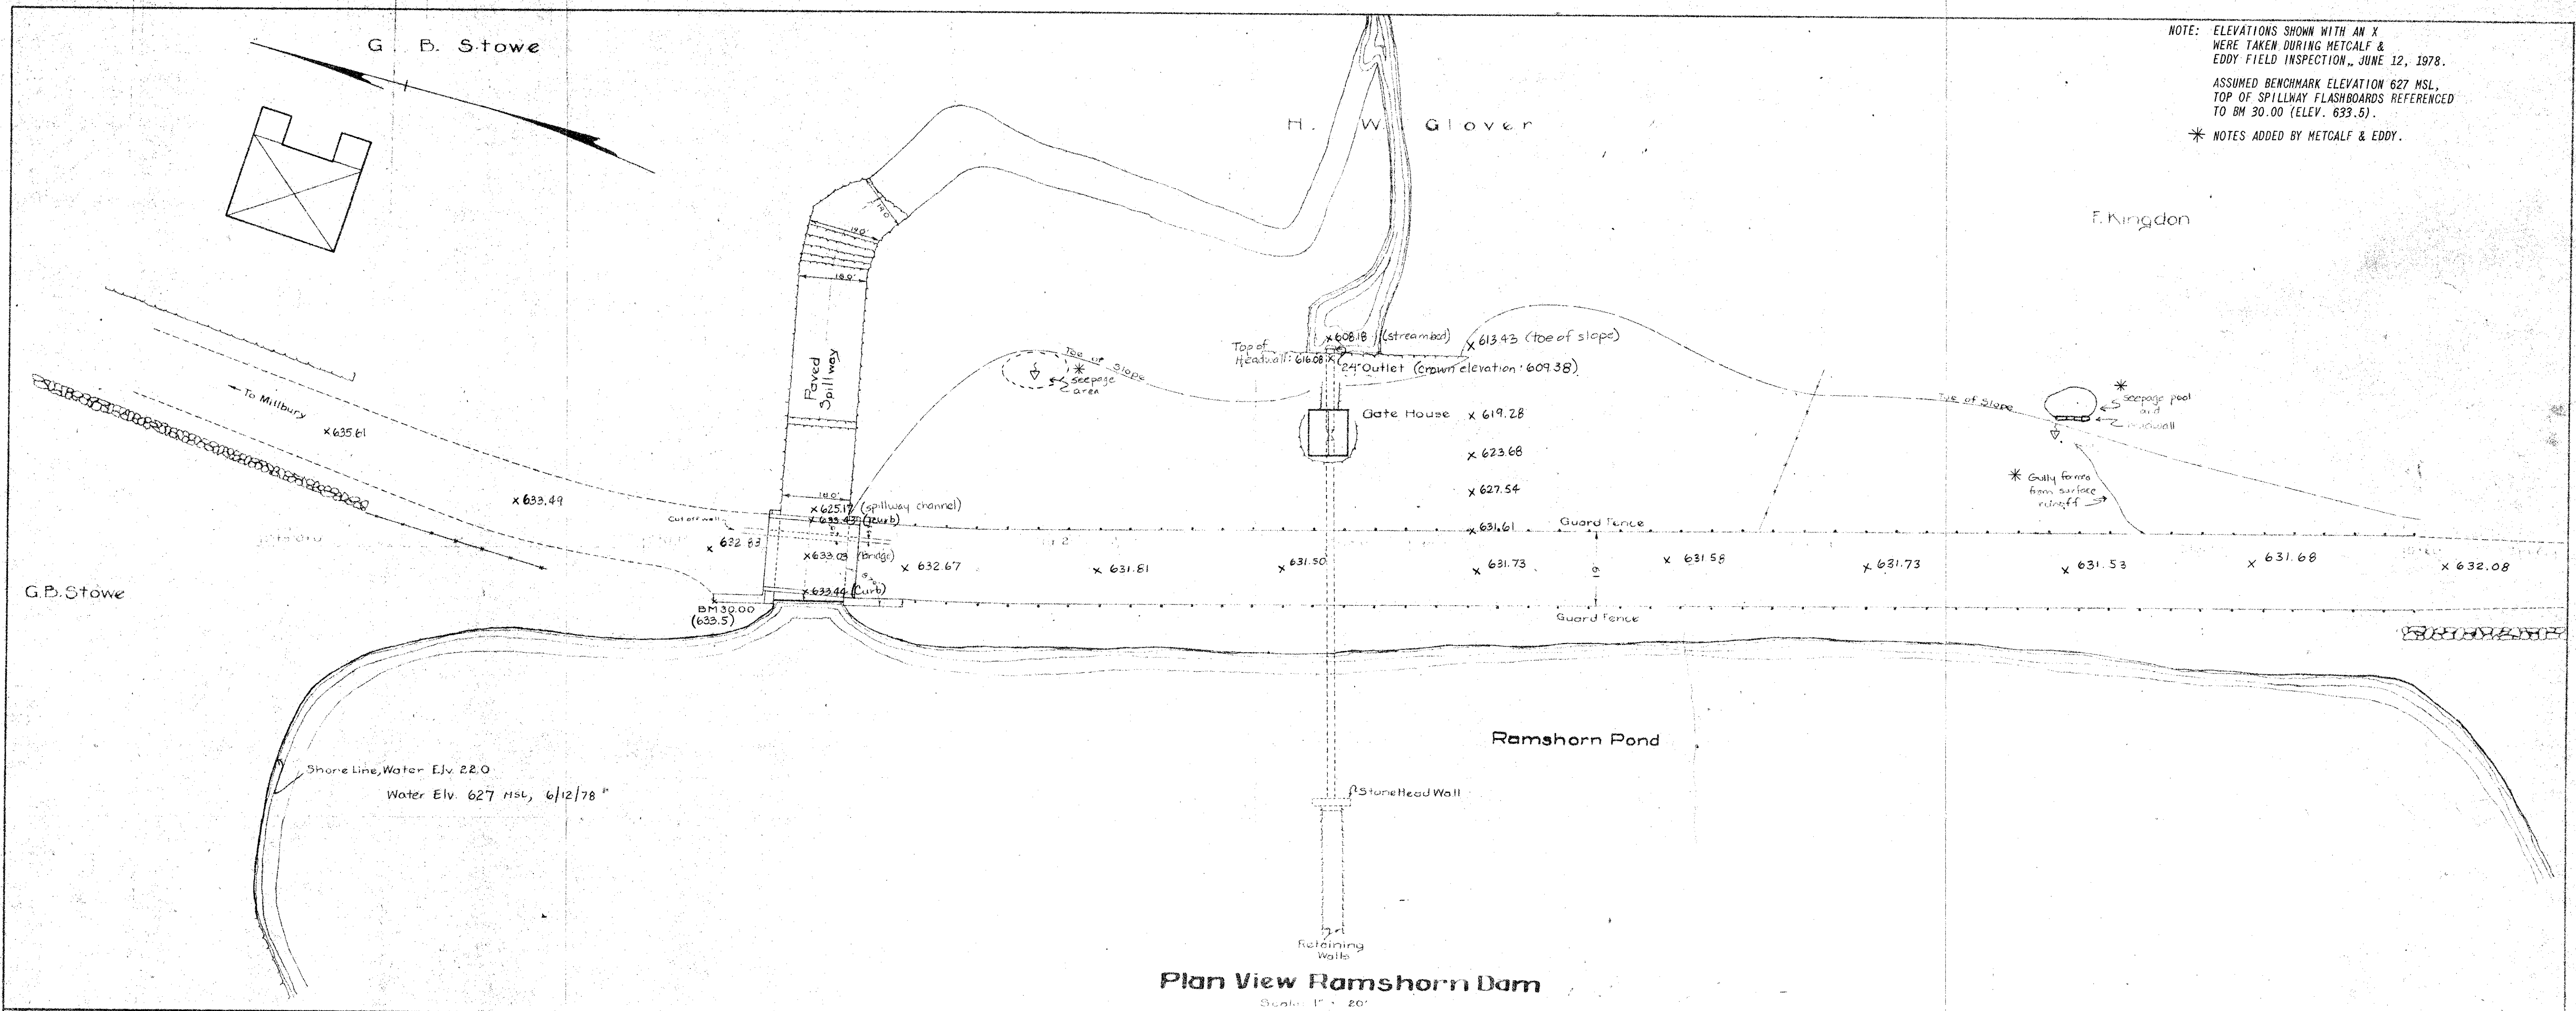
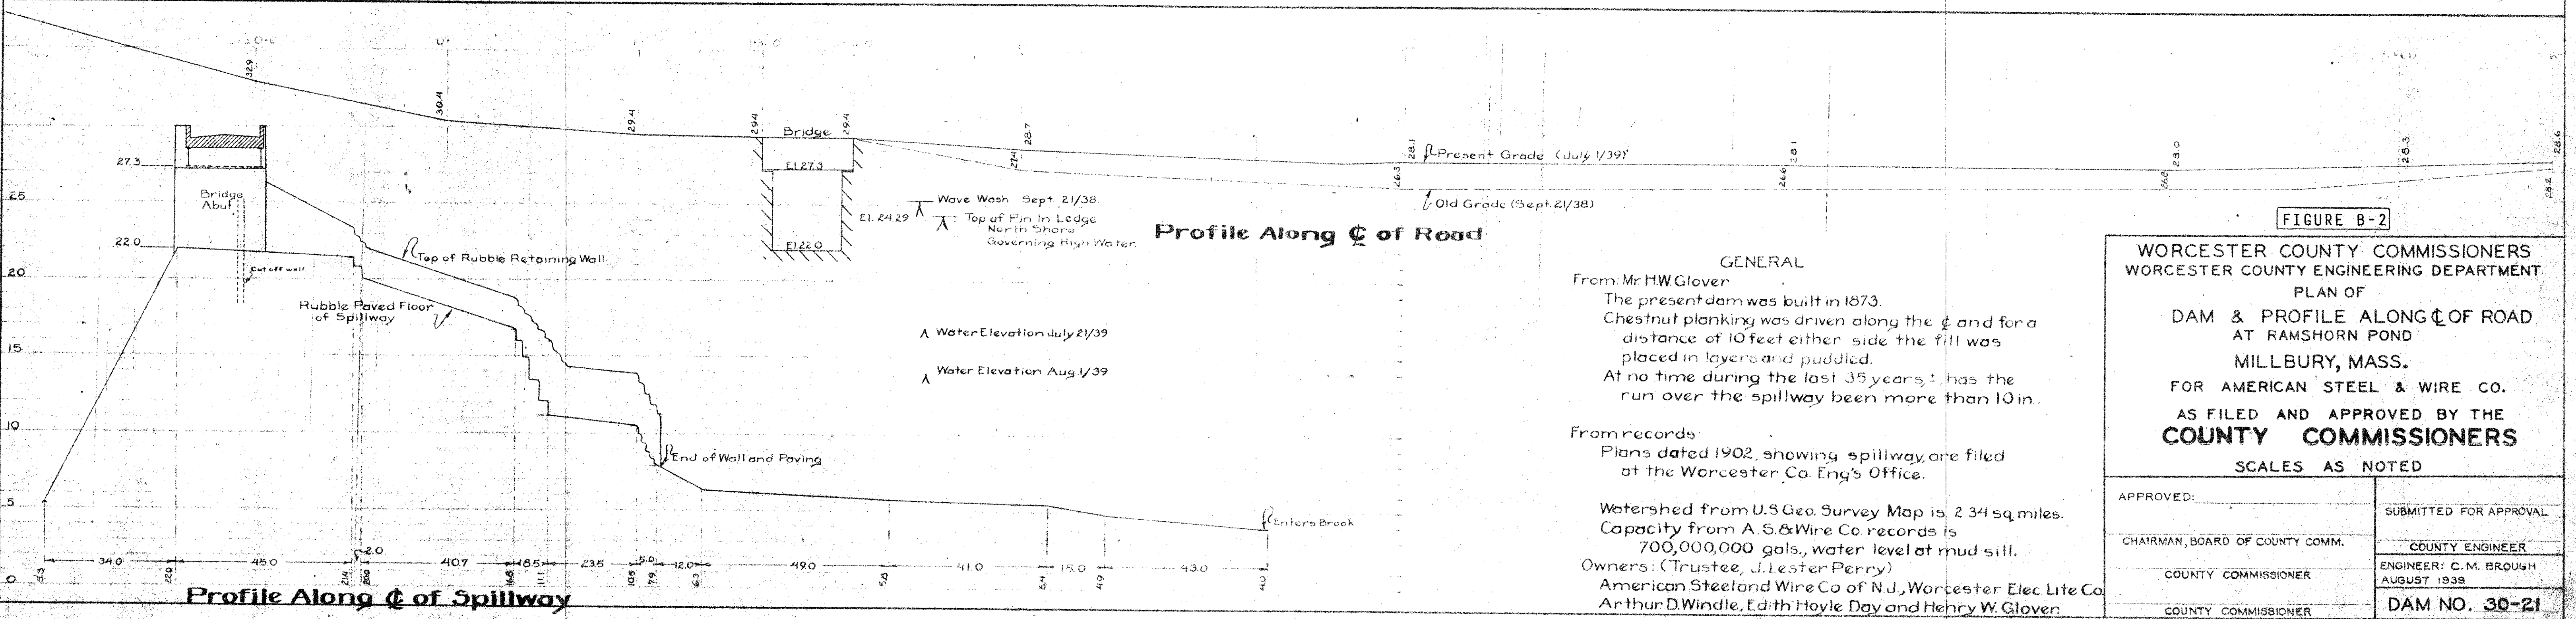
- d. Overtopping Potential. Overtopping of the dam is barely expected under an inflow test flood of 2,040 cfs; as noted previously, however, the records on overtopping indicate that the dam was overtopped during the 1938 flood but was not overtopped in 1955. Figures B-2 and B-3 in Appendix B show the dam was raised about 2 feet in 1939.

It was learned that this dam was originally built in 1825, probably of local soil or rock materials. As discussed in Section 1, Paragraph 1.2.h, changes were made in the dam in 1873, 1915, and 1939. As noted in Figure B-2, the cutoff consists of chestnut planking driven along the centerline and for a distance of 10 feet either side. The fill was placed in layers and puddled.

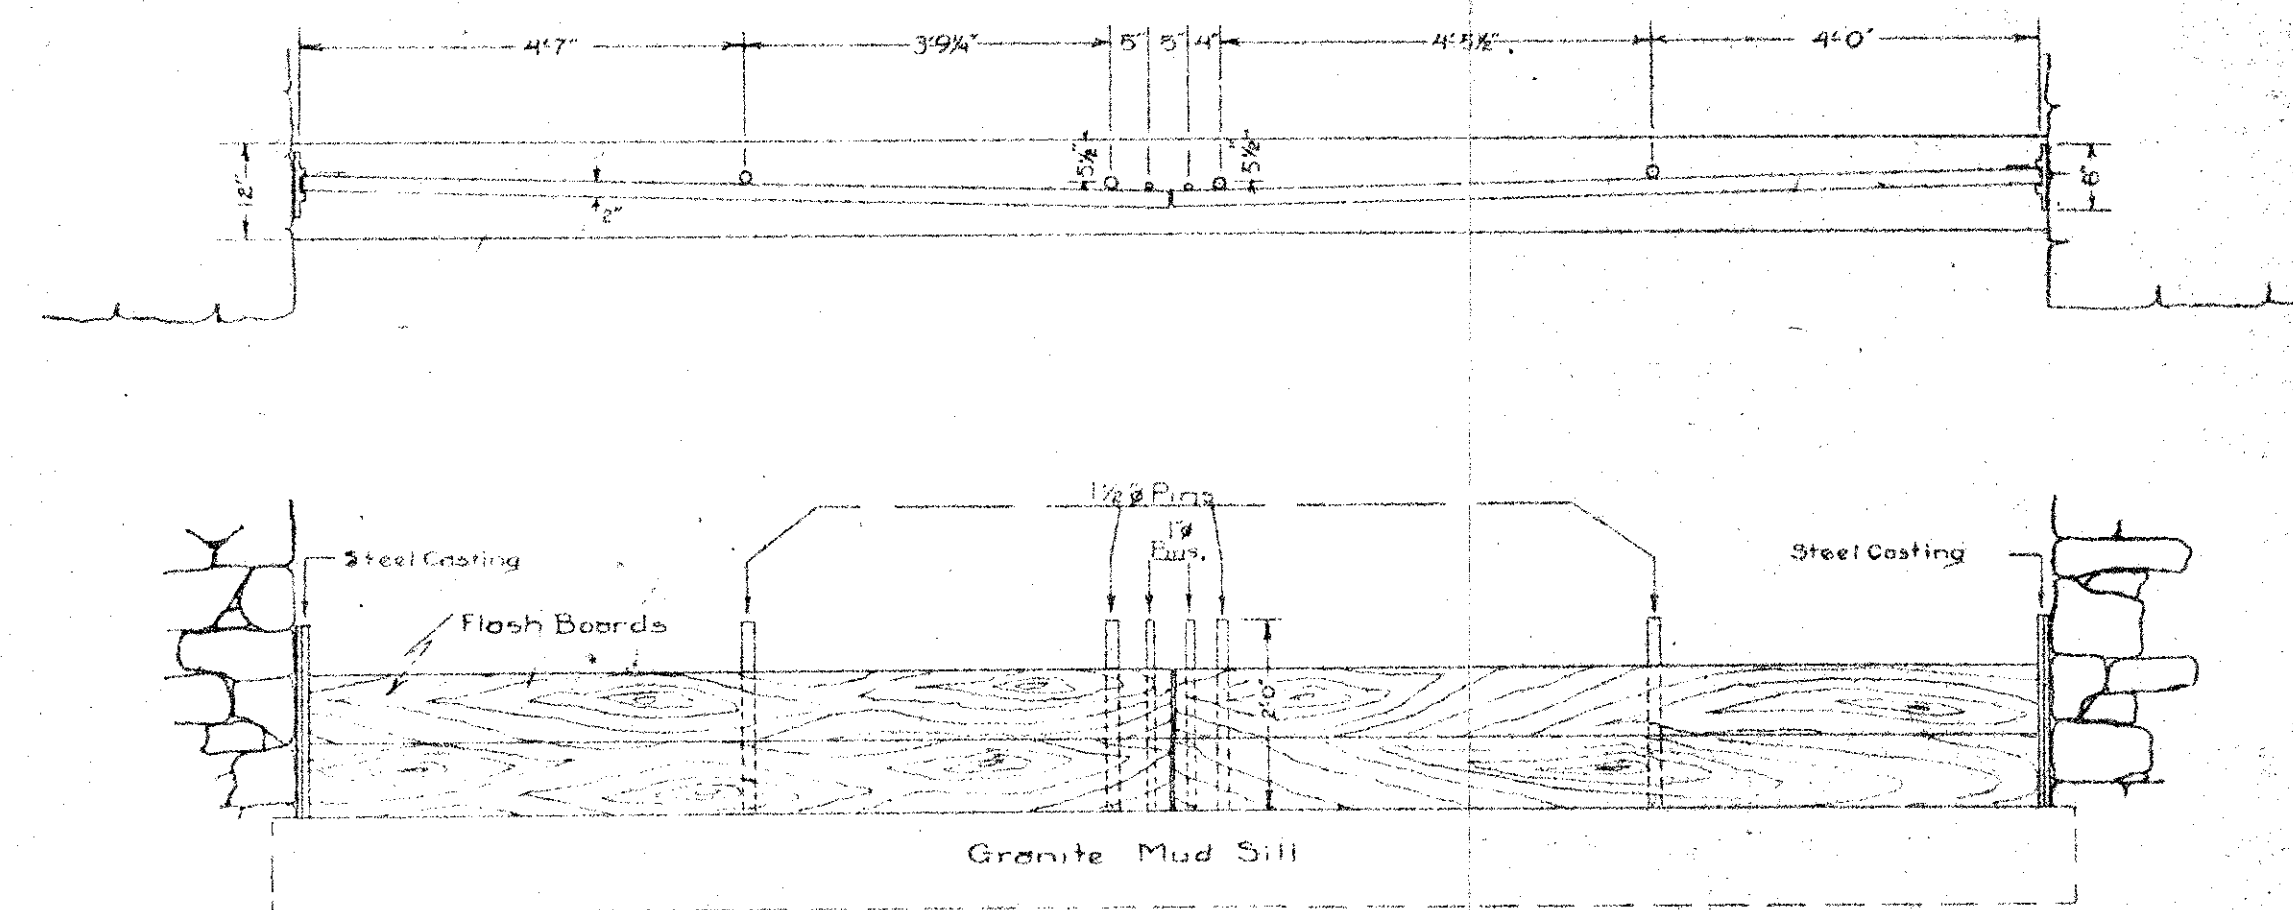
Plan and Elevation of Flashboards
Scale: 1/2" = 1'

- * FLASHBOARD DETAILS NOT AS SHOWN. THE FOLLOWING MODIFICATIONS WERE NOTED, JUNE 12, 1978:
- 2 FLASHBOARDS - ONE 8-INCH (UPPER), ONE 11-INCH (LOWER)
 - 5 PINS - 1 3/8-INCH IRON PIPES EVENLY SPACED ALONG FLASHBOARDS

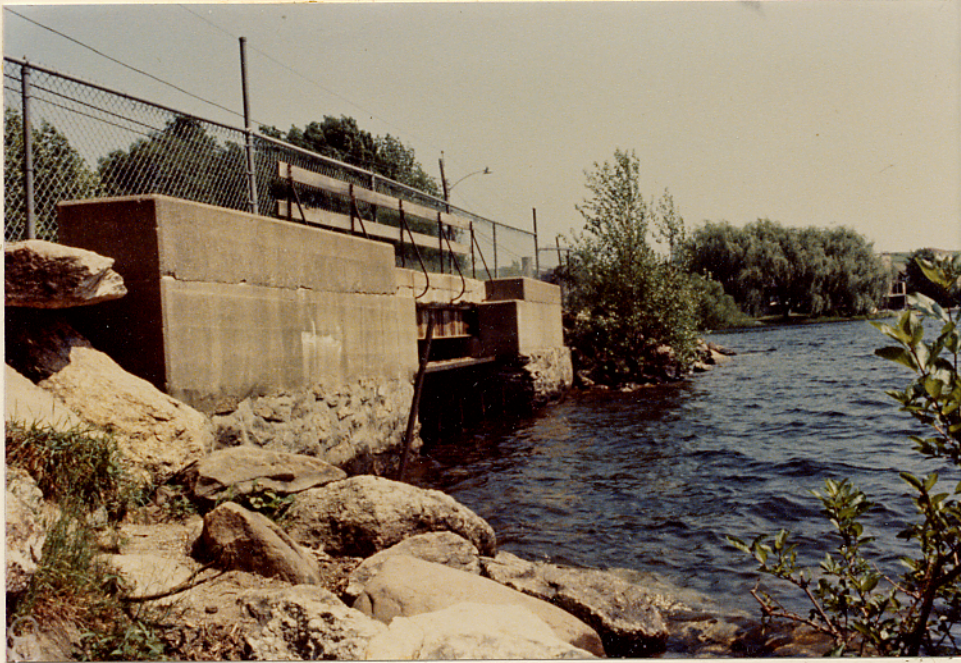
The spillway headwall has minor cracks in the concrete (see Photographs C-1 and C-2, Appendix C). Two flashboards (bottom 11-inches high, top 8-inches high) were braced by five evenly spaced iron pins. There were gaps between the flashboards where water is spilling through. There is also minor erosion on the concrete at the southern end of the flashboards. The concrete under

NO. 1 - SPILLWAY INLET AND HEADWALL

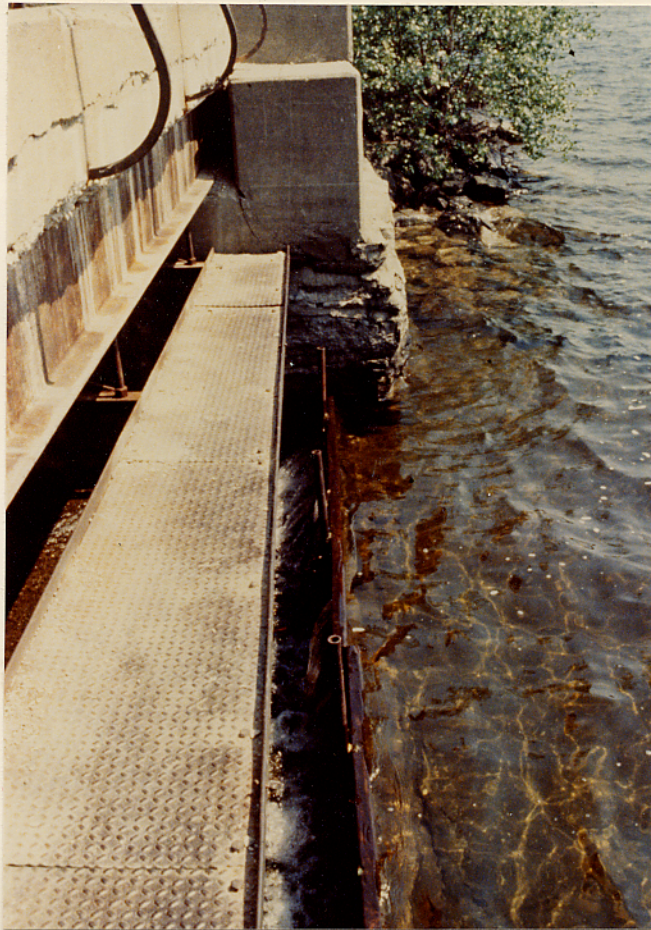
NO. 2 - FLASHBOARDS AND WALKWAY AT SPILLWAY INLET

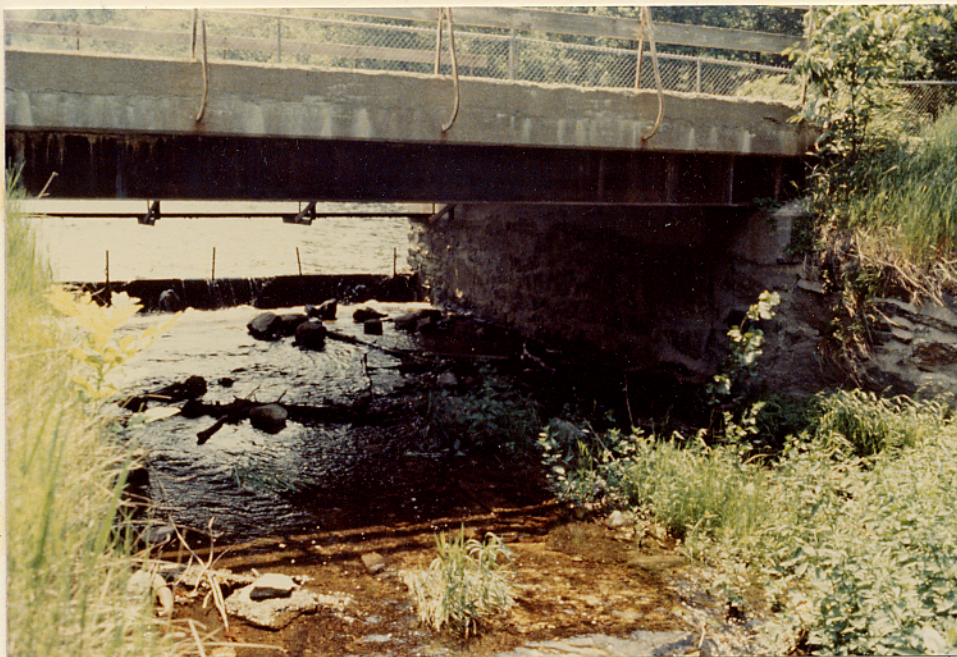
the bridge is deteriorating, as are the concrete curbs on either side of the roadway. The spillway channel is in good condition, although there is some debris and vegetation in the channel. On the north side of the channel there is a 5-inch drain in the training wall from which water flows at an estimated 5 gpm. The source for this flow is unknown. There are small trees overhanging the lower earth spillway channel.

**NO. 3 - SPILLWAY CHANNEL UNDER DOLAN ROAD
UPSTREAM VIEW**

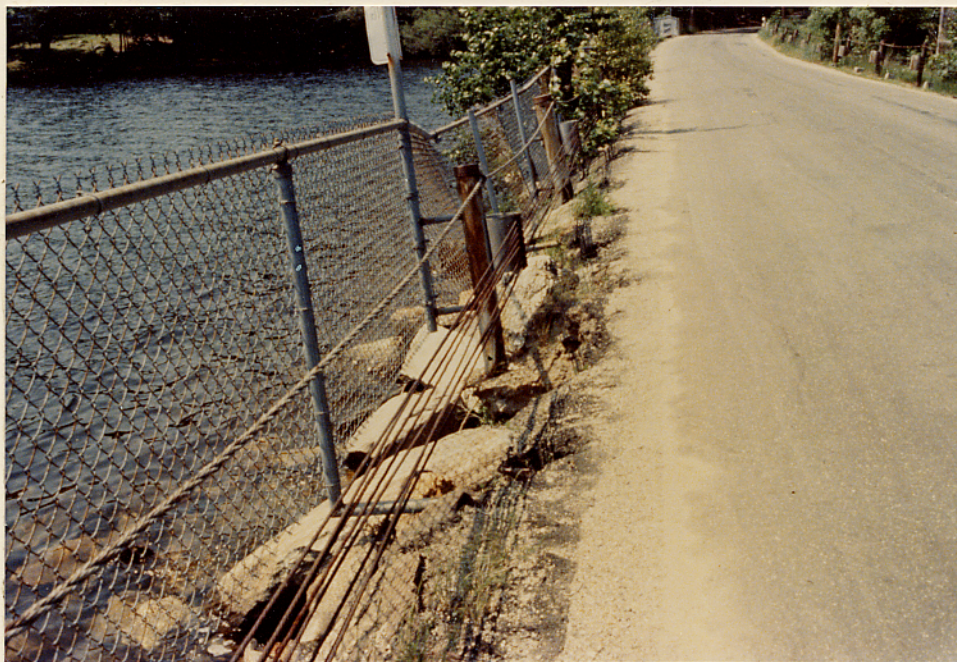
- b. Dam. The dam is an earthfill embankment with a bituminous concrete roadway on the crest. The upstream face of the dam is riprap that shows signs of slumping. In addition, the top of the upstream slope has gullies caused by runoff from Dolan Road. Photograph C-4 in Appendix C shows the amount of deterioration on the upstream side of the crest and the buckling of the fence. It appears that an attempt to protect the slope and the fence was made by paving the slope with asphalt. The riprap at and below the present water surface appears to be in fair to good condition. Generally, the upstream face was clear of debris, with only small trees, brush and shrubs growing on it.

NO. 4 - UPSTREAM DAM FACE SHOWING EROSION AT TOP OF SLOPE

- (2) replace and/or repair riprap
- (3) repair the leaking gate valve stem
- (4) remove brush and trees from the dam
- (5) clear all debris from the spillway
- (6) fill in all animal burrows
- (7) institute a definite plan for surveillance and a warning system during periods of unusually heavy rains and/or runoff
- (8) implement a systematic program of inspection and maintenance. As a minimum the inspection program should consist of a monthly inspection of the dam and appurtenances and supplemented by additional inspections during and after severe storms. All repairs and maintenance should be undertaken in accordance with all applicable State regulations.
